Special Report for the period September 1986 to March 1987

# Durability Testing of an Iridium-Plated Storable Rocket Engine Injector

September 1987

Air Force Astronautics Laboratory

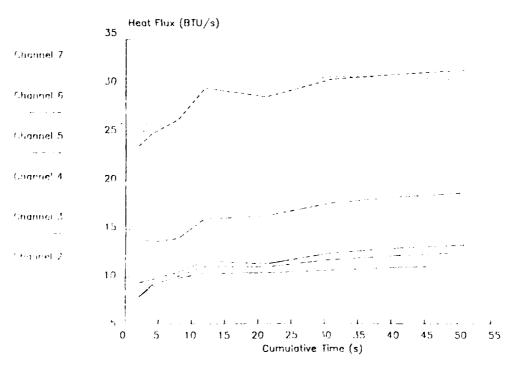
Calorimetric data obtained during each test firing is presented in Table
4. The STAP Tech combustion chamber was designed to reach thermal equilibrium
in less than 0.5 seconds. Inspection of the calorimeter data for tests 3 and
4 revealed increasing heat flux throughout the duration of the firing. In
addition, heat flux at the start of Test 4 is close to the high heat flux
obtained at the end of Test 3. To illustrate this phenomena more clearly,
Figure 6 shows calorimetric data for selected channels plotted as a function
of time.

Figure 6. STAP Tech Calorimeter Data

Disassembly and inspection of the hardware following Test 4 revealed increased surface roughness of the combustion chamber due to metallic deposits. The deposit locations correspond to channels where increased heat flux was observed. A possible explanation is that increased surface roughness due to metallic deposits caused a corresponding increase in the heat transfer coefficient. The deposited material was probably nickel which eroded away from the injector face. Similar phenomena was observed on the Breadboard XLR-132 program.
